PRELIMINARY ASSESSMENT OF EFFECTIVENESS OF PRECUT TECHNIQUE IN CONTROLLING
TRANSVERSE CRACKS FOR ASPHALT PAVEMENT IN INTERIOR ALASKA

A
THESIS

Presented to the Faculty
of the University of Alaska Fairbanks

May 2016

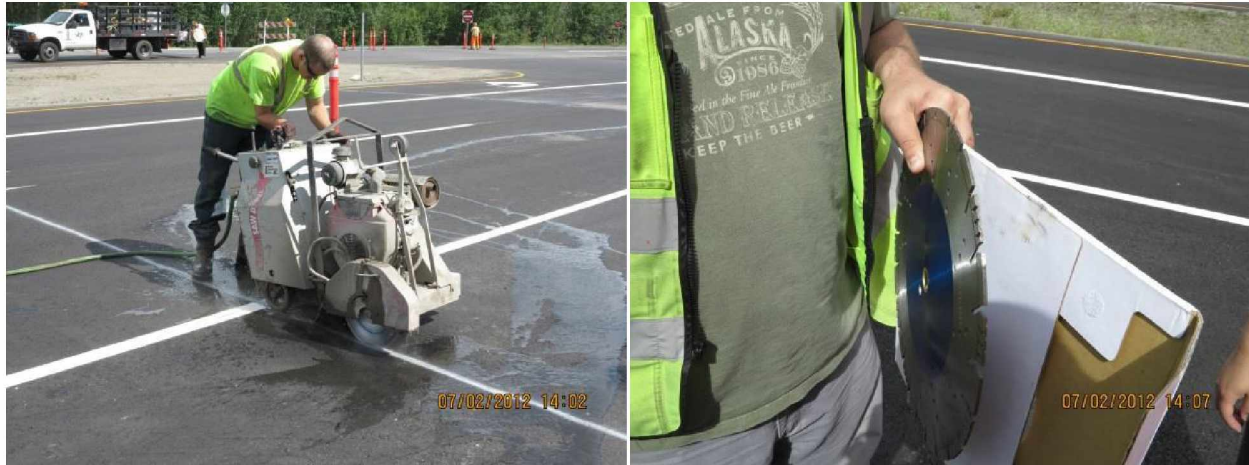
Figure 3.1 Saw Devil equipment and operator (left) and thin diamond saw blade used (right)

The equipment used was a Saw Devil walk-behind saw machine with a 12 inch diamond saw blade (1/8 inch thick) and a flatbed truck with a 300 gallon tank of water for cooling the saw blade. The time required to layout and cut the first two thirds of each line was approximately 12 minutes, or about 15 minutes total per line plus time required to move the cutting operation from one lane to the other. This time was averaged over several of the different depths of cuts. Figure 3.1 shows the saw equipment as well as the type of thin diamond saw used at Moose Creek.

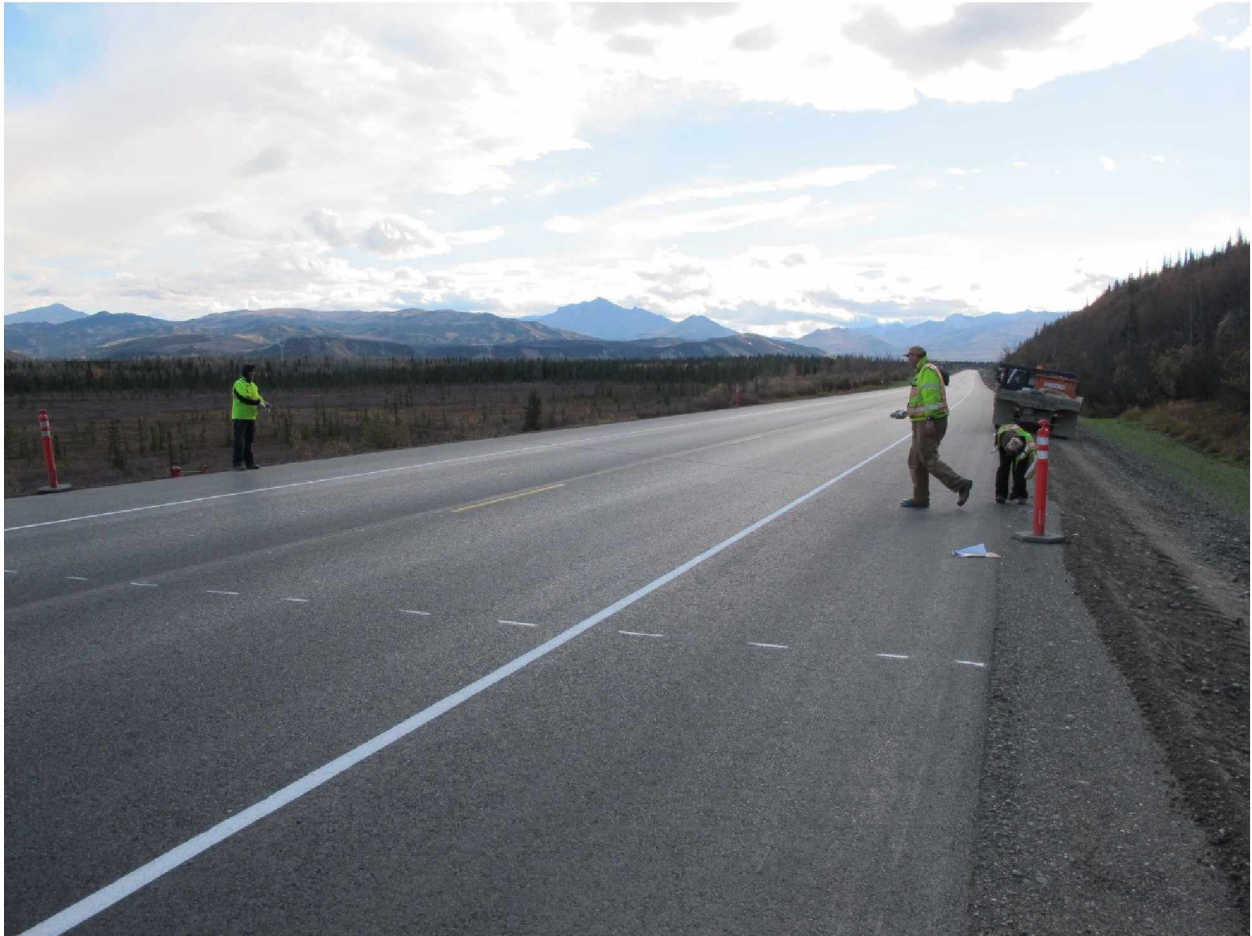
Figure 3.2 Surveyors laying out precuts with rabbit-tracks

designated stationing and crack separation distances. Precuts were marked on the asphalt with spray paint using the rabbit-track technique (Figure 3.2) where short dashes were sprayed across the full width of the road. The crack layout process took approximately one full day with all six individuals working; one surveyor, three laborers, and two flaggers.

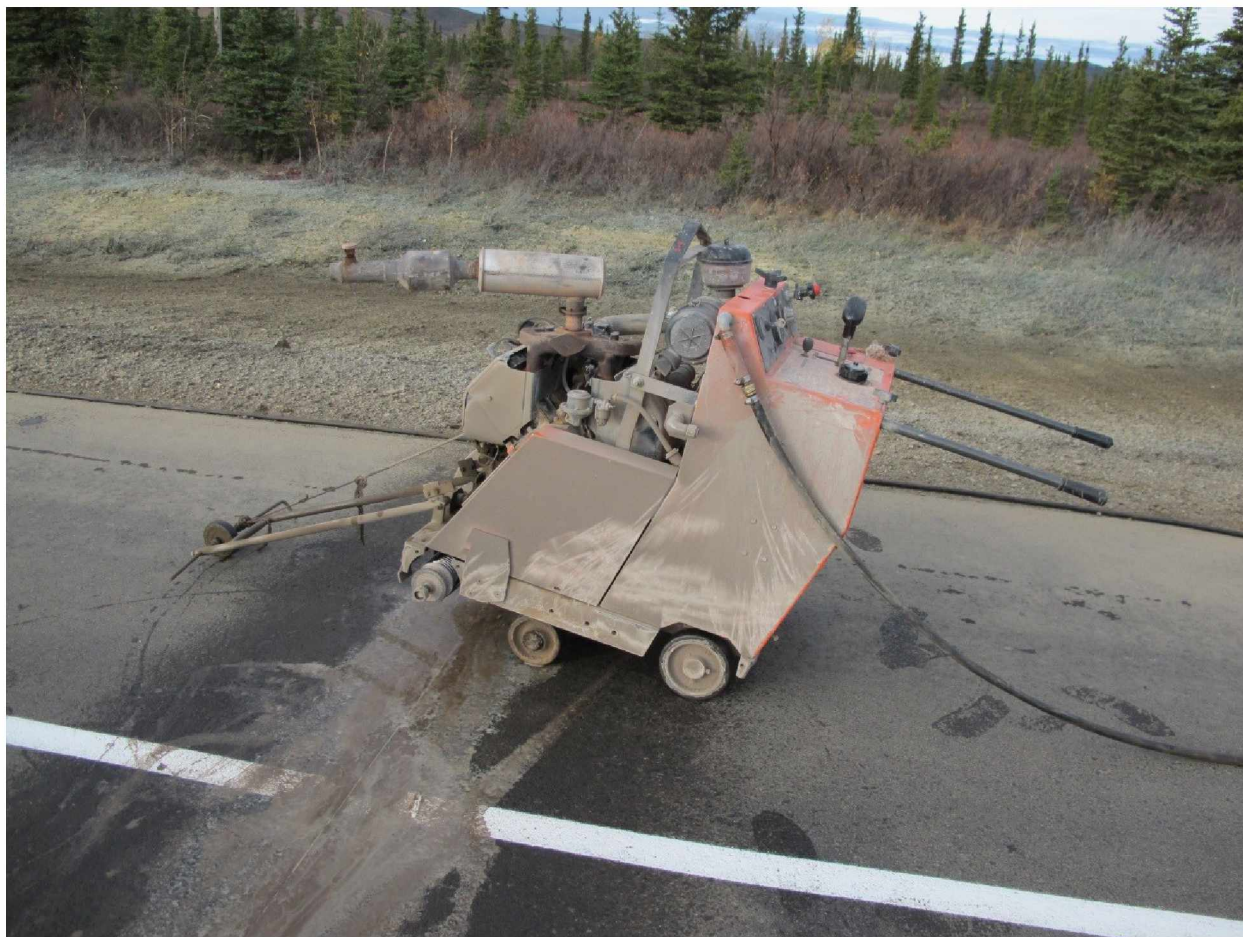
Figure 3.3 Precut cutting equipment

The precuts were sawed into the pavement using a walk-behind saw machine similar to that of the “Saw Devil” brand with a 12-inch diamond tooth blade 1/8-inch wide (Figure 3.3). Other equipment included one pickup truck with a water tank and equipment lift and one water truck to refill the water tank. ADOT&PF used a ruler during construction inspections to ensure compliance with the precut plan, (Figure 3.4).

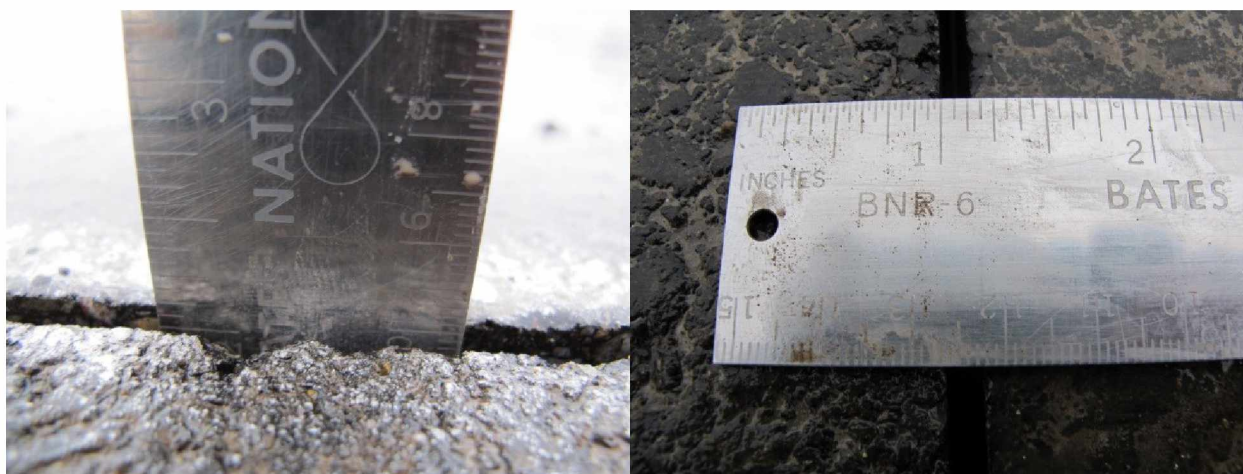
Figure 3.4 Inspection of crack depth (left) and crack width (right)

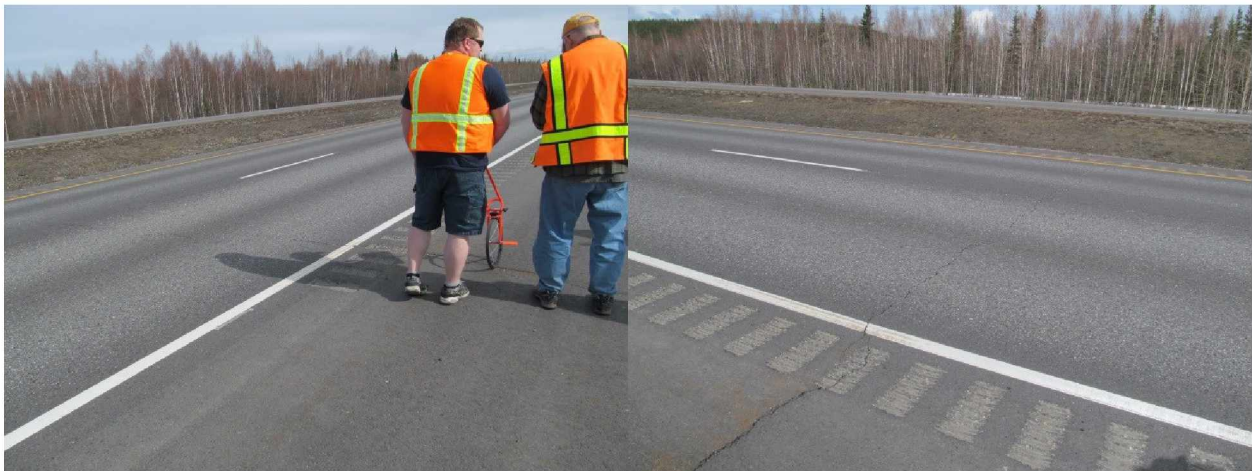
Figure 3.5 Field survey of Moose Creek, 2014 (left) natural transverse crack (right)

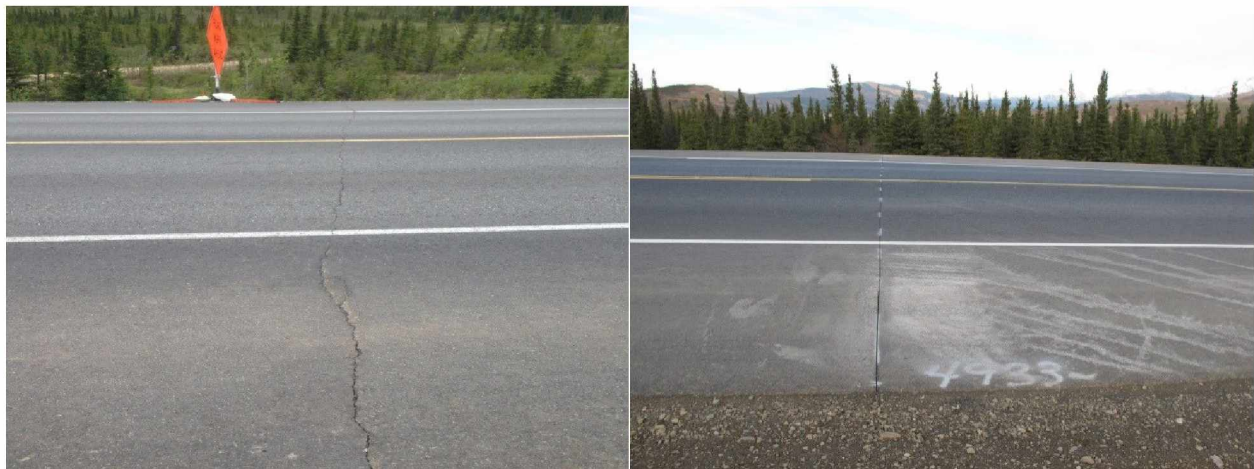
Figure 3.6 Natural transverse thermal crack at Healy (left), precut at Healy (right)
